Reporting Date: July 2018 Version: Final

SAFERWHEELS

Study on Powered Two-Wheeler and Bicycle Accidents in the EU

Final Report

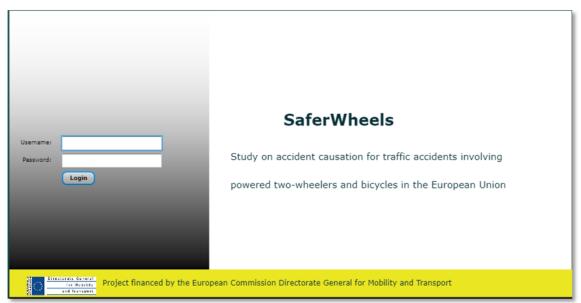
Figure 3: SaferWheels database application login web page

Figure 3 and Figure 4 show the login and home page of the web database application used for data entry.
